Long-Distance Grouting, Materials and Methods Grouting Conference 2003

Abstract

An abandoned 1600-meter (mile-long) rock tunnel had to be completely filled with grout. The total tunnel volume was approximately 4500 cubic meters (6000 cubic yards). The tunnel was water-filled with access only at each end through narrow, 25-meter deep (80 ft), vertical shafts. Access for pumping was feasible only from one end of the tunnel, thereby requiring unusually long distances for pumping.

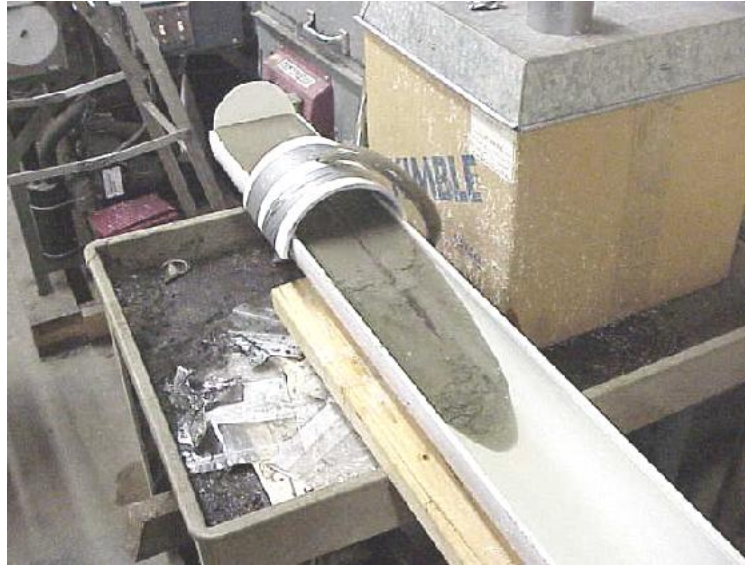
Figure 2. Model test of grout placement in a tunnel full of water

The second bench-scale test was devised to model the horizontal displacement of the water in the tunnel as the grout is placed. The setup was a half-pipe full of water with a grout tube inserted at one end. A long slope of grout pushing the water forward was expected. As the photo in Figure 2 shows, there was actually a surprisingly steep face of grout (1:5 vertical : horizontal) that formed. Again, there was essentially no mixing of the leading edge of the grout with the water.

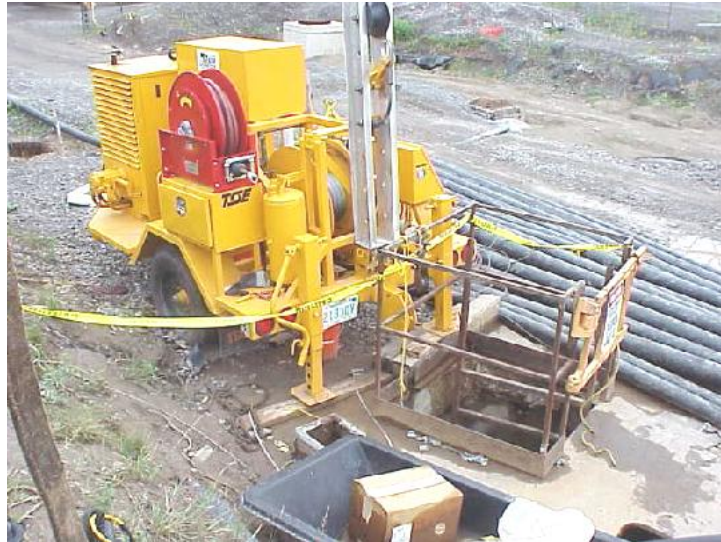
Figure 3. Pipe puller and shaft at the shore end of the project

Fabricated rollers were installed at the base of the access shafts to allow pipes and cables to be pulled through without damage. This was accomplished using divers. Next a small remote-operated vehicle went through the tunnel carrying a small diameter cable. This cable was used to pull through a larger cable that was about 3200 meters (10,000 ft) long. This cable was wound onto cable drive pipe pullers at both end of the tunnel so that it could travel back and forth through the tunnel, dragging in the many components of the grouting system. Considerable attention was paid to the details of cable connections to avoid the possibility of snagging on a previously placed component.

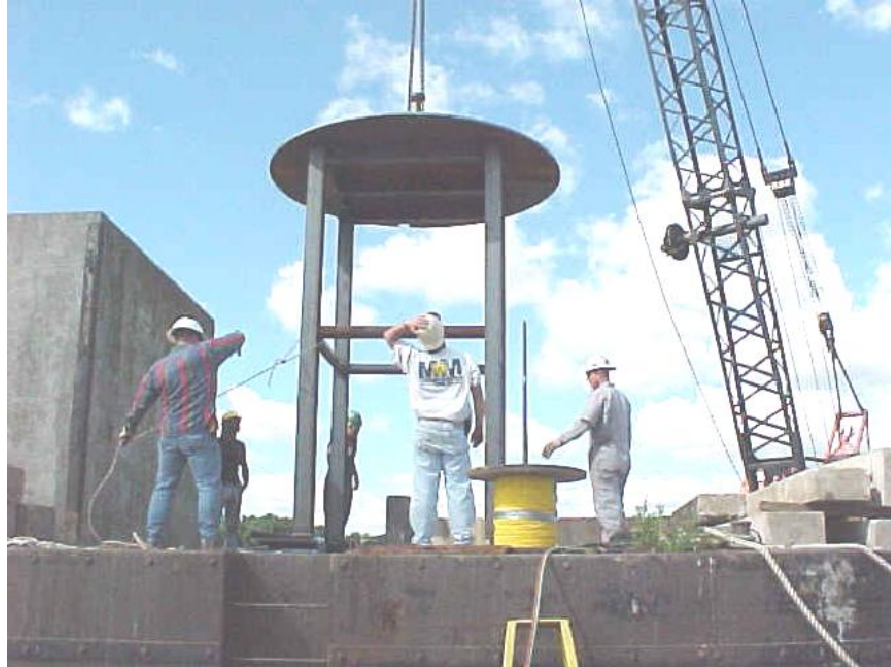
Figure 4. Placing the steel “stool” in the river shaft in preparation for the tremie seal

Once the pipes were all placed, it was time to block the river shaft so that grout would be forced back towards the shore once pumping started. This was accomplished by placing a steel “stool” in the shaft, sealing around the edges and pouring tremie concrete on top of the structure to seal the shaft. After this was done, the only grout pipe left accessible from both ends was the secondary grout pipe.

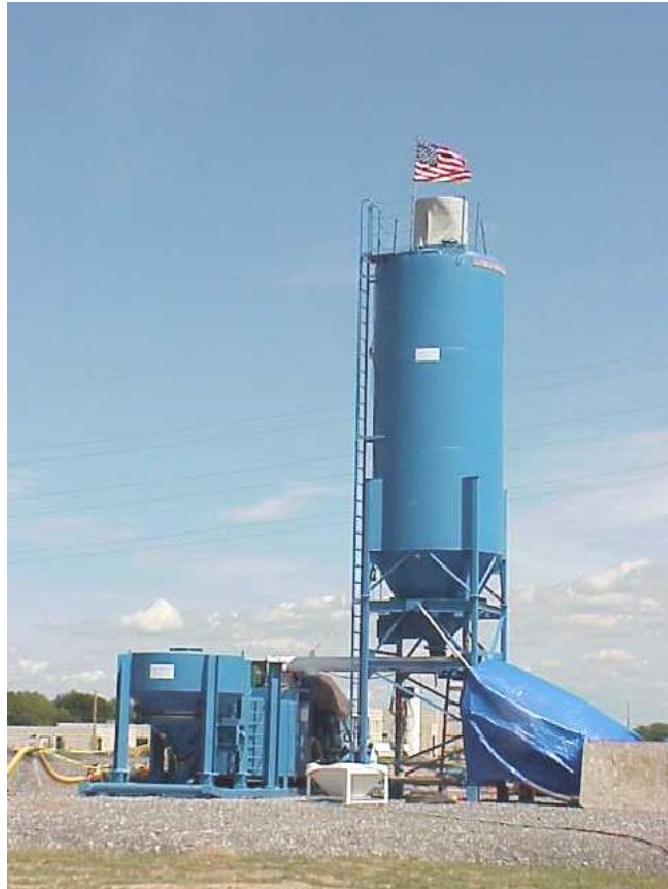
Figure 5. Grout mixing plant

The one-component mixing system was crucial to the project design since it would allow for a continuous as opposed to a batch mixing system. The mix plant consisted of a 4.5 cubic meter (6 cubic yard) capacity colloidal enclosed mixer fed by a variable flow liquid system and a variable speed dry material feed system. The level in the mixer was controlled by a sonar device; feed rates of the materials were adjusted based on real time continuous density measurements provided by a highly accurate coriolis density meter. Slurry was pumped in a rate sufficient to keep the level in the mixer constant as the material was pumped out and the rate of feed for the cement blend was controlled based on density.

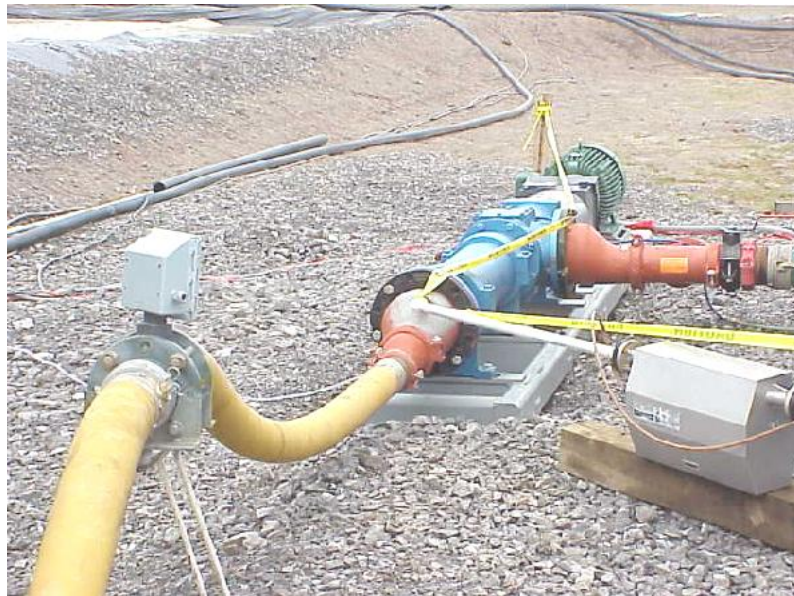
Figures 6. Pumping unit with density meter to the right and flow meter to the left.

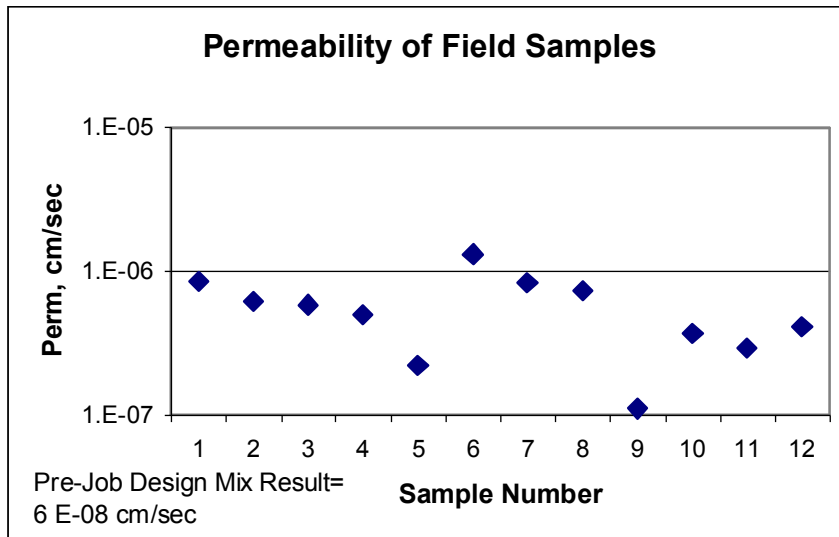
Figure 8. Permeability of samples taken during the work

Throughout the grouting operation, samples of the grout mixture were collected for strength and permeability testing. The results, Shown in Figures 7 and 8, show that the quality of the grout consistently met the project objectives of greater than 100 kPa unconfined strength and less than 1×10^{-6} cm/sec permeability after 28 days of cure.
